Walls Case Study

Tyssedal Skule, Odda, Norway

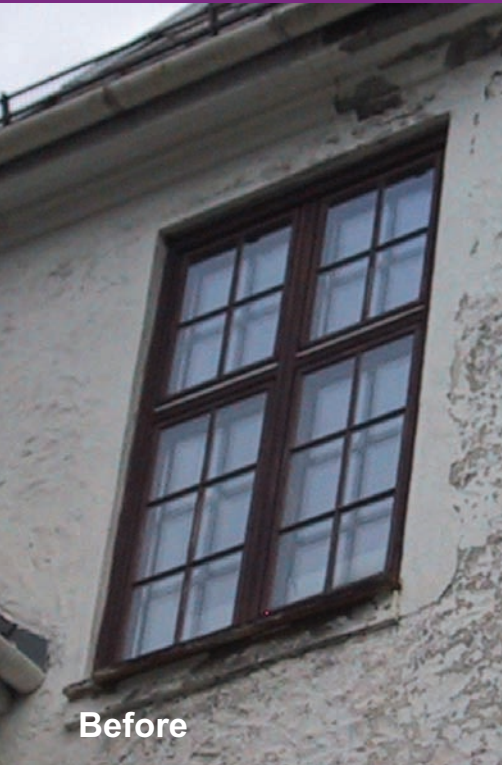
Before

This is a beautiful old school building with rendered brickwork that had previously been coated with an unknown, non-elastomeric paint.

The building's façade needed an upgrade because the old paint was very worn and flaking. There were also a large number of cracks and areas of damage to the render. The surface required repair with an elastomeric, waterproof coating.

Monolastex RE – an elastomeric, crack bridging coating from Liquid Plastics – was specified for the project. Liquid Plastics' Bonding Primer was first used to make the surface stable and to ensure the bonding of the new coating. Any cracks in the surface were secured by an additional application of Flexitape in the embedment coat of Monolastex RE.
